## DOTs Use Ditch System to Repair Outfalls, Slope Failures

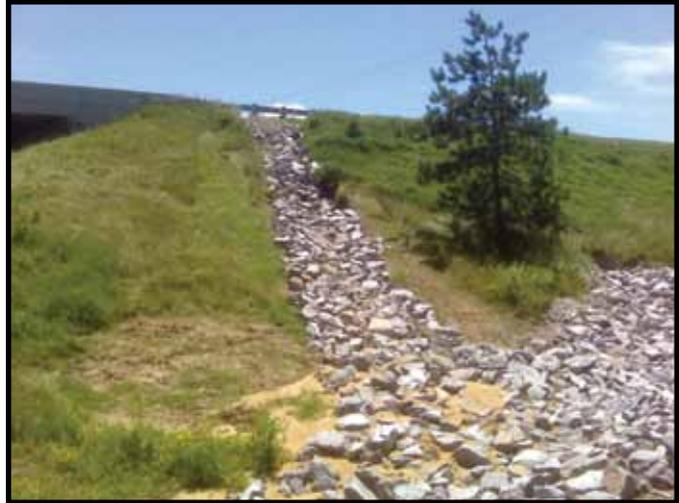
In Wisconsin, SmartDitch replaced a riprap channel to eliminate a severe storm water runoff situation. Flooding and erosion were undermining the road above and the underpass below. The project included 107 ft of 24-in. SmartDitch, which was installed in two separate ditches to handle runoff. The slope was approximately 3:1 (horizontal to vertical) on the longer ditch and 5:1 on the shorter ditch. The installation was completed by the local county's maintenance crew. Including excavation, the project was completed in two days.
