[SEWER REHAB]

Solving the Sinkhole Epidemic

Addressing the heart of the problem: damaged sewer lines

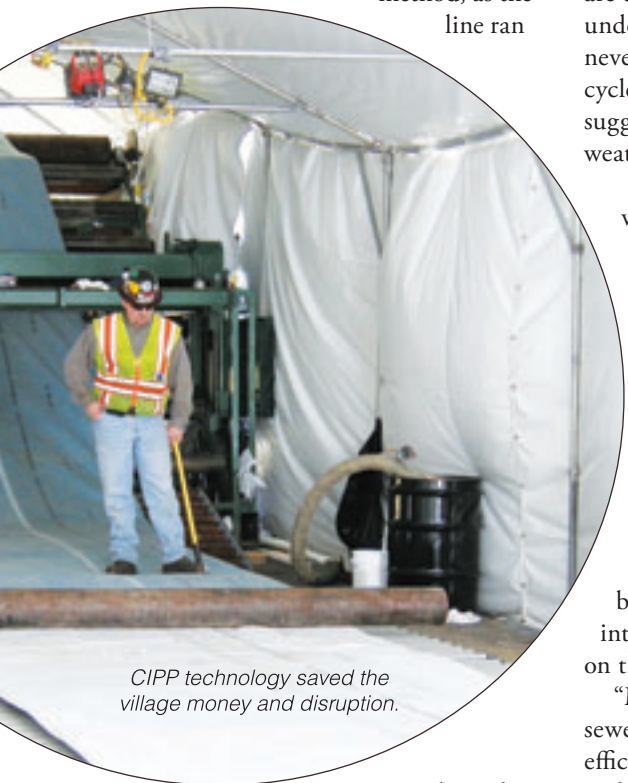
CIPP technology saved the village money and disruption.

The felt tube manufactured by Insituform is coated on one side with a polyethylene layer and then treated with a resin-based solution during the “wet-out” process. The tube is inserted into the pipe and then cured into a hard, permanent pipe inside the host pipe using hot air, water or steam.
