# SKEETER SOLUTION

Pervious paver stops mosquitoes from colonizing in storm drain catch basins

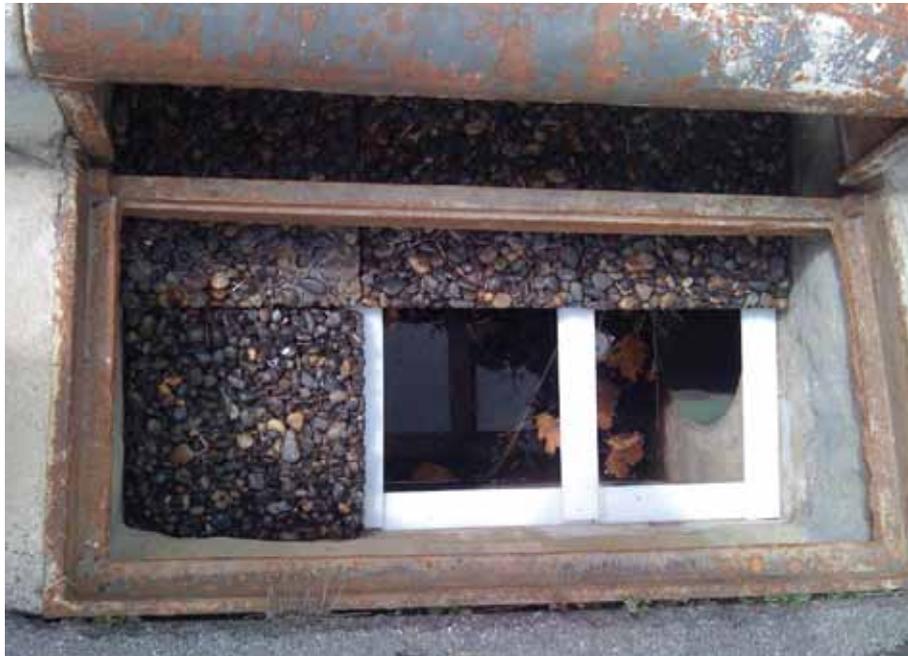
with an overflow pipe using an internal butterfly valve.

a shelf of pavers placed inside a storm drain inlet system, below the inlet grate and above the standing water in the sump. The concern that the pavers would become plugged was addressed

pavers and the resulting overflow carried debris into the overflow pipe, which then got caught on the butterfly valve and caused the pipe to plug up. Instead of discarding the idea entirely,

the problems were readdressed with a better understanding of what was actually occurring. The pavers were reconfigured to allow the decomposed granite to pass through while catching the gross contaminants (particles bigger than 30  $\mu$ ). The overflow pipe was enlarged and redesigned to use an external flapper valve.

The paver tray system was installed and tested, but the system failed. Decomposed granite and sediment indigenous to the area plugged the
